# ***Phragmites*: Controlling the All-Too-Common Common Reed**

## **Massachusetts Wetlands Restoration Technical Notes**

Wetlands Restoration & Banking Program  
Massachusetts Executive Office of Environmental Affairs

Technical Note Number 1 April 1995

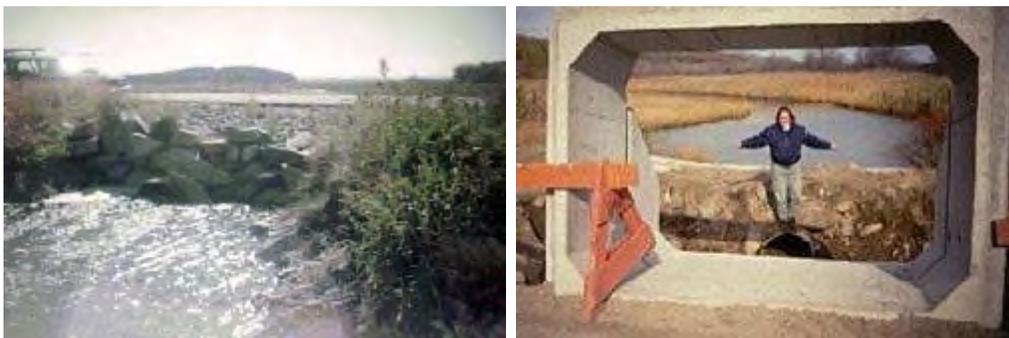
This restrictive culvert at Argilla Rd. in Ipswich has now been replaced by a much bigger box culvert, allowing the natural flow of the tide.

1. *Tidal restrictions* - reduced flooding and salinity of salt marshes.

7. Increase tidal flow and salinity (for controlling common reed in former salt marshes). Successful technique. Requires increasing size of culverts, installing self-regulating tide gates, or otherwise removing the restriction to permit more tidal water exchange. May be enhanced through open marshwater management which involves increasing salt water flooding through selective ditching and ponding. This has resulted in a significant die-back of common reed after four years. Installation of self-regulating tide gates can both increase tidal flooding with salt water and protect low-lying developed areas from storm floods, thereby providing environmental, safety, and economic benefits.

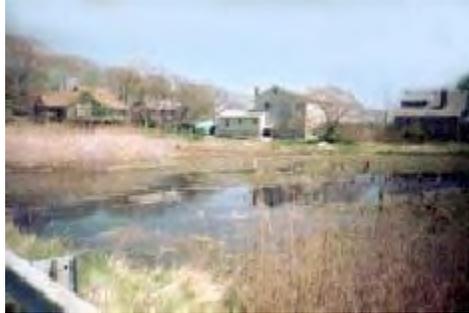
Stormdrain discharge has led to increased elevation, favoring Phragmites on this site in Rockport, MA

3. *Water quality degradation* - stormwater discharges, increased nutrient inputs, introduction of road salts, and other forms of water pollution also seem to provide Phragmites with a competitive advantage over native species.
